In-situ Repair of the Stator Core of Hydro-generator Establishing the Process

Similar situation was faced when fault occurred on a 180MW hydro-generator. The repairs were carried out without core disassembly and replacement. Finally, a repair process was formulated to facilitate such in-situ repairs with more confidence and ease.

7.2. Occurrence of Fault

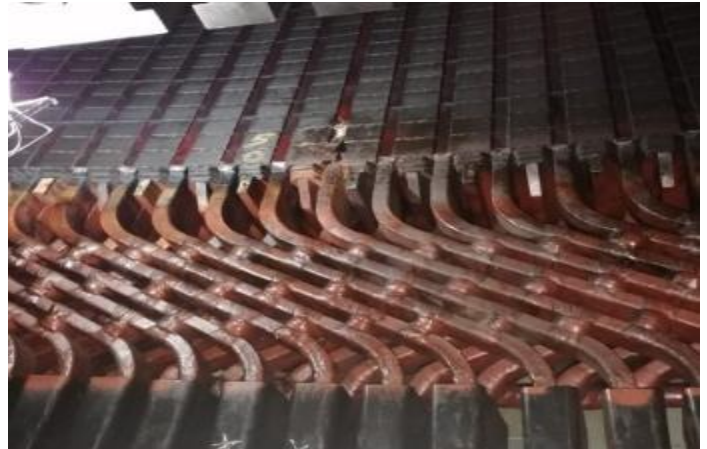
Visual inspection of winding and core shown some flashover in lower area of the winding near Slot No.-51 (Fig. 1 and Fig. 2). Winding Bars in Slot no-51 segregated and IR was tested on them. Results were satisfactory. Further sectionalization of winding in faulty path (Y1) was carried and IR tests carried out.

Figure 1. Visual Inspection - Rotor Poles removed

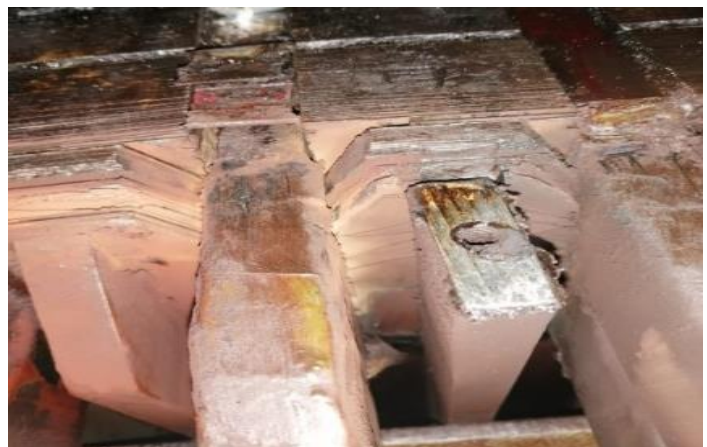
Figure 2. Burnt out Step Laminations

During inspection of the area around the seat of fault it was observed that the step laminations and finger of slots 50, 51 and 52 in the lower end area of stator core were found damaged due to heating. lamination packets between slots 50, 51 and 52 were found disturbed/loosened (Fig. 4). Two number air ducts just above the packet of loosened laminations were found blocked.

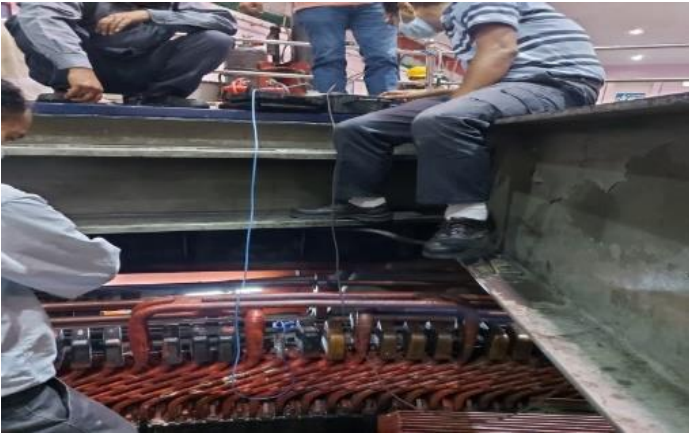
IR of a section of winding covering around 25 slots found zero. To avoid further sectionalization, controlled DC current, up to 60-70 amperes, was injected in the faulty section of winding using a welding machine. Minor spark was observed in slot-52. Bars in the slot were segregated. IR of bottom bar in slot-52 was found to be zero (Fig. 3).

Figure 3. Testing of Stator Sections

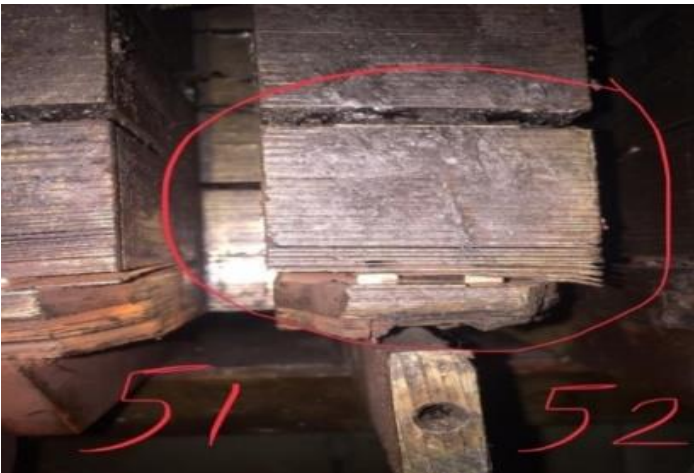
Figure 4. Loosened Laminations

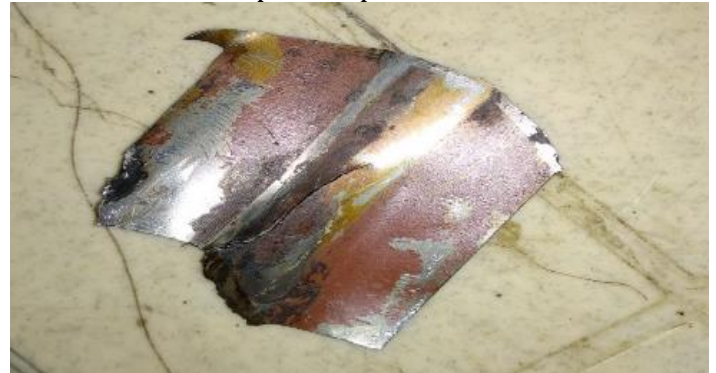
Outer edges of about 15 laminations in lower most portion had vaporized completely while partially burnt-out edges of about 25 laminations were in place. A piece, measuring 50 x 50 mm (Fig. 5), of one such lamination between Slot-51 and 52 had got torn from the remaining lamination and moved from its place by about 2-3 mm. Upon inspection of the punctured bottom bar, a cut-groove about 25mm in length, 2-3 mm in width and 2-3 mm in depth was observed (Fig. 6). The position of the groove was corresponding to the displaced piece of step lamination. Thus, it was concluded that the displaced piece of step lamination had gradually cut into the bottom bar in slot 52, thereby puncturing it and resulting in earth fault at the point of puncture.

Figure 5. Torn-out Piece of Lamination

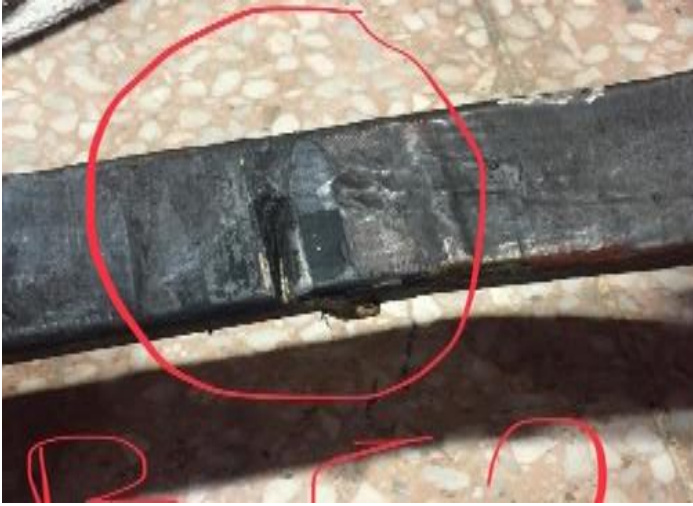
Figure 6. Damage on Bar due to Lamination Piece

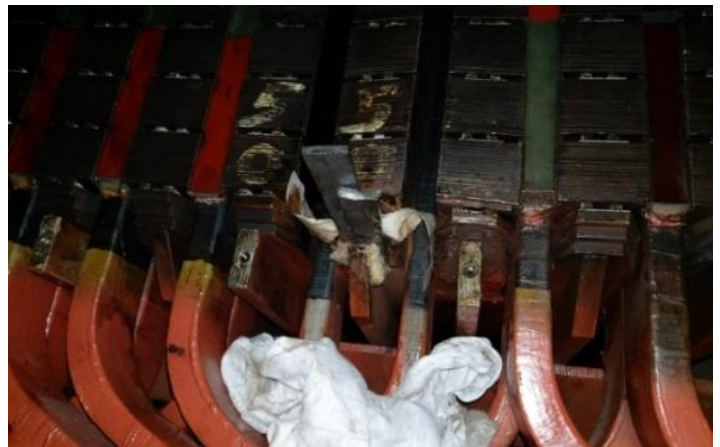
Figure 7. Localized Repairs Undertaken

- Removal of Bottom bars in slot 50 and 51
- Removal of remaining identified bars, to facilitate the repair work of core laminations.
- Removal of rotor poles
- Removal of stator hot air coolers for cleaning and inspection of back of the stator core
- Removal of burnt-out outer portions of the laminations
- Cleaning of area around and in between the laminations including the air ducts
- Insertion of core insulation varnish in between the laminations
- Preparation of nomax paper packing (nomax paper dipped in epoxy varnish)
- Insertion of above packing in between the laminations for providing tightness and insulation (Fig, 7).
- Preparation of packing (wool-felt dipped in epoxy varnish)

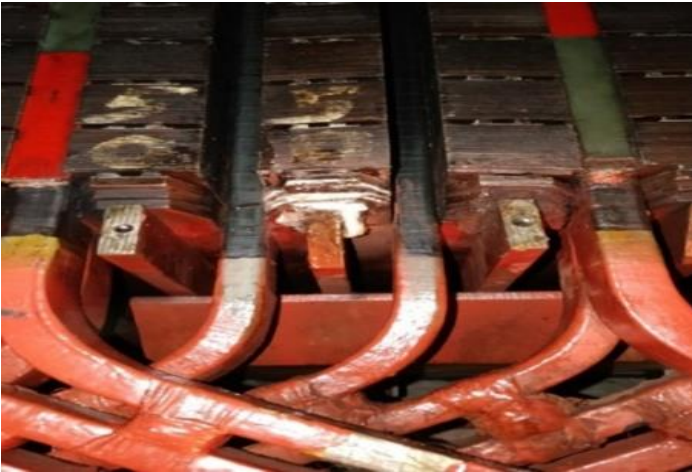
Figure 8. Repaired Laminations

- Insertion of above packing in between the laminations for providing tightness and insulation (Fig, 8).
- Reopening of the air ducts blocked by debris.
- Checking/tightening of stator core bolts.
- Replacement of damaged winding bars in slot 52 (2 bars)
- Replacement of other bars (14 numbers, removed for replacement of the bottom bar in slot 52.
- Repair of damaged core
- Testing as per procedure.
- Cleaning of entire stator core air ducts and winding overhang.
- ELCID test of stator core carried out and found satisfactory.
- Application of core varnish and semiconductor paint and left for drying.
- Insertion and assembly of rotor poles carried out.
- Refitting of stator air coolers which were removed.
- Final inspections
- Final testing, cleaning.

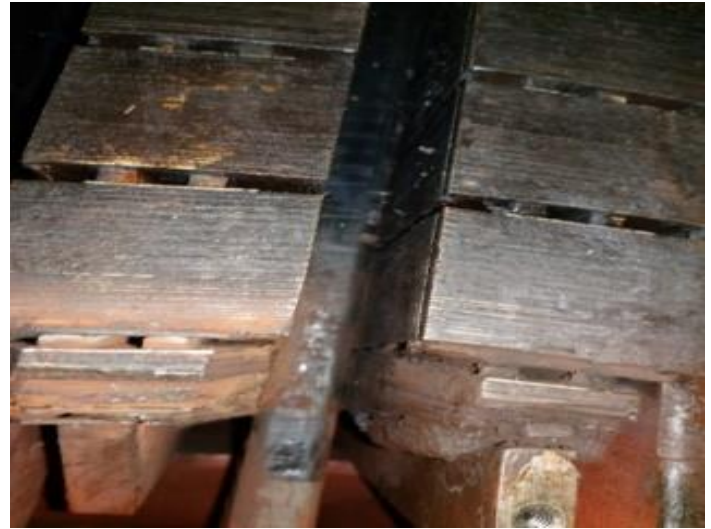
Figure 9. Loosened Laminations

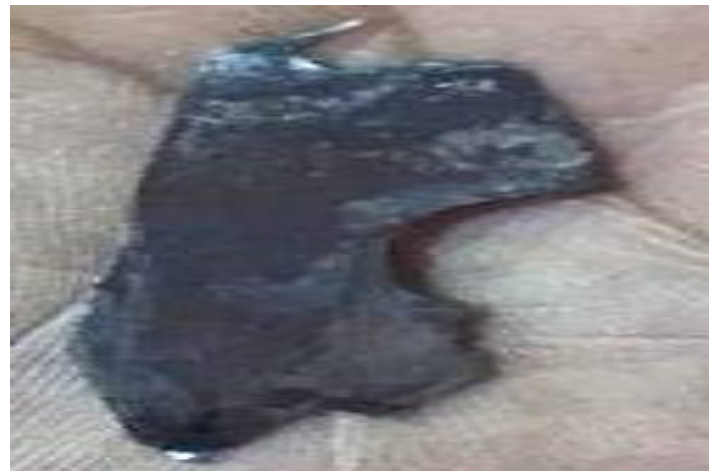
After a period of around one year (on 18-07-2020), a similar problem reappeared in another section of the stator. This time, the outer visible edges of step laminations in the lower end of the stator core (between slot 50 and 51) had got heated up, leading to vaporization of some laminations and loosening of step laminations between slot 50 and 51. Also, the packet of laminations just above step laminations had also loosened (Fig. 9). A piece, measuring 25 mm x 25 mm (Fig. 10) of one such laminations between Slot-50 and 51 had got torn from the remaining lamination and got displaced from its position by about 8 mm to 10 mm. This piece cut a groove of about 20 mm x 2 mm and 1-2 mm depth into the top bar in slot 51, thus puncturing and grounding the top bar.

Figure 10. Piece of Lamination

Besides this damage, no damage or deterioration was observed in the laminations in adjacent slots repaired in the previous year. The fault was repaired in exactly the same manner and by adopting the same process as adopted in previous year.

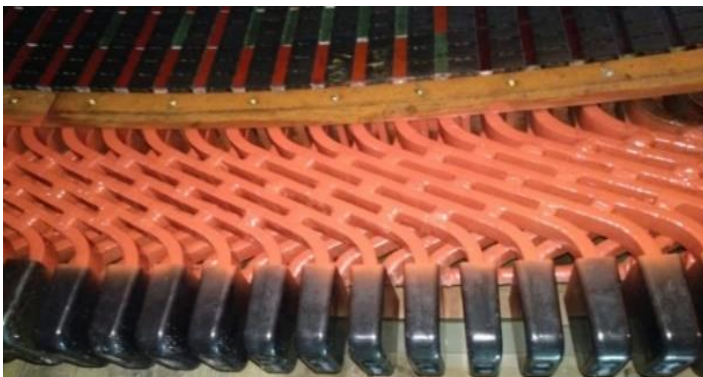
Figure 11. Lower Overhang Area after Repairs
